ARMY AIRCRAFT SAFETY PERFORMANCE REVIEW
DOCUMENT IDENTIFICATION
DEC 1992

Army Aircraft Safety Performance

FY
87
through
FY
91

UH-60
OH-58D
AH-64
MH/CH-47D

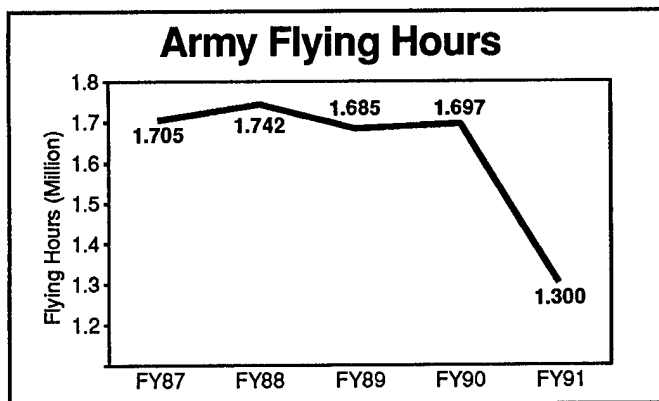
Figure 1-1

During the 5-year period of FY 87 through FY 91, the Army experienced 181 Class A flight accidents, 54 Class B accidents, and 366 Class C accidents. Figures 1-1 through 1-5 display Armywide performance during this period. The DOD accident classification criteria used to classify these accidents is shown at table 1-1.

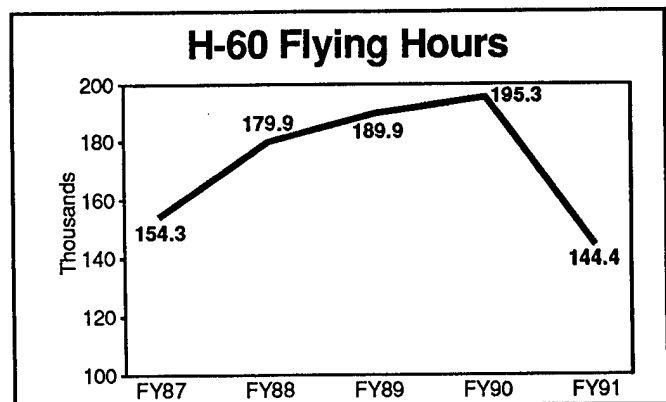
Figure 2-1 shows a significant increase in H-60 flying hours through FY 90. The reduction in FY 91 resulted from flying hours being pulled from units and given to DS/S deployed units.

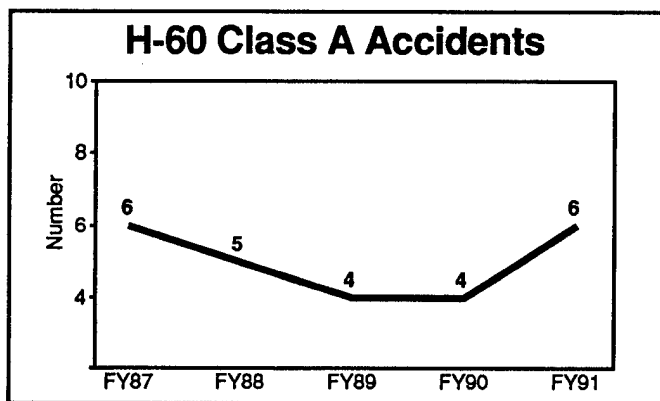
Figure 2-2 shows H-60 Class A accidents. Particularly noteworthy is the fact that, until

DS/S, Class A accidents steadily decreased while flying hours steadily increased.

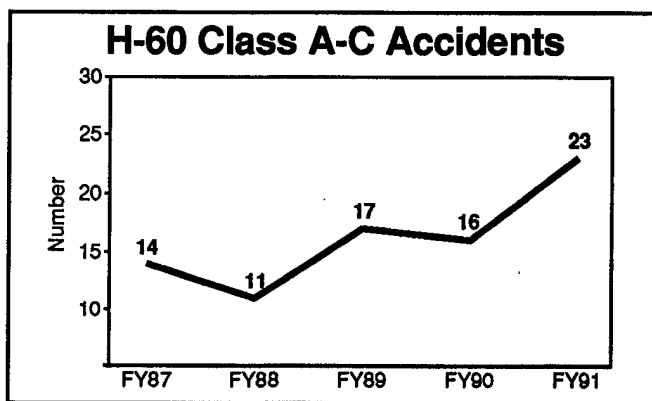
Figure 2-3 shows the H-60 Class A-C accident trend. FYs 87 through 90 show a slight increase, with FY 91 skewed by DS/S accident experience.

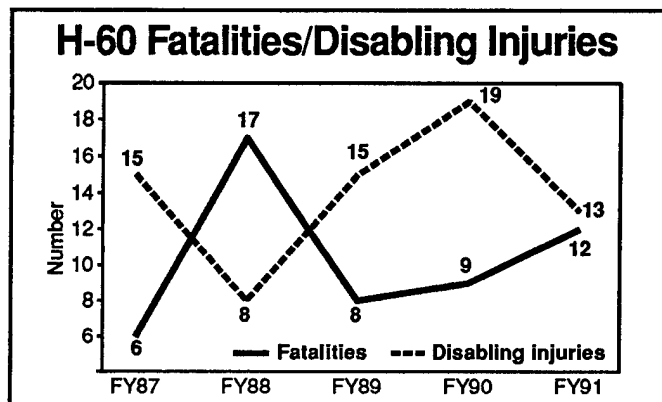
Figure 2-4 shows the fatalities and disabling injuries resulting from H-60 accidents. The dramatic increase in fatalities in fiscal 88 resulted from a midair collision between two H-60s that killed 17 soldiers.

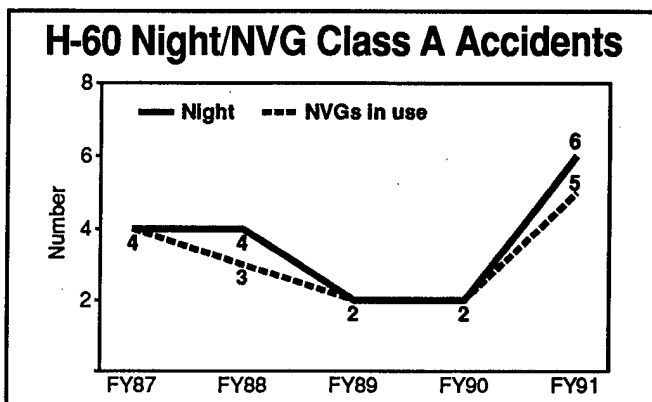
Figure 2-5 shows H-60 Class A accidents that occurred at night and those that occurred with NVGs in use. Note that in all but 2 of the 18, NVGs were in use.

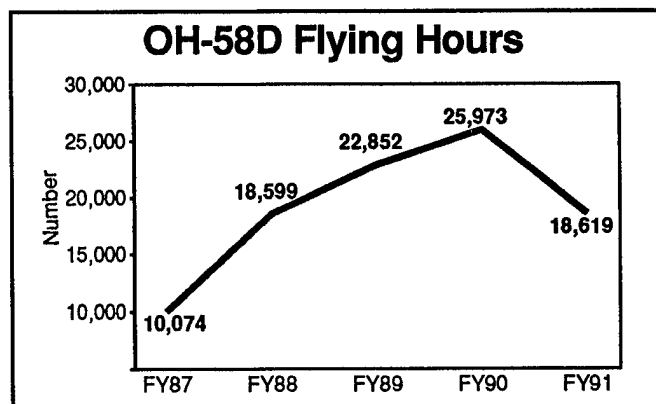
Figure 3-1 shows a significant increase in OH-58D flying hours through FY 90. The reduction in FY 91 resulted from flying hours being pulled from units and given to DS/S deployed units.

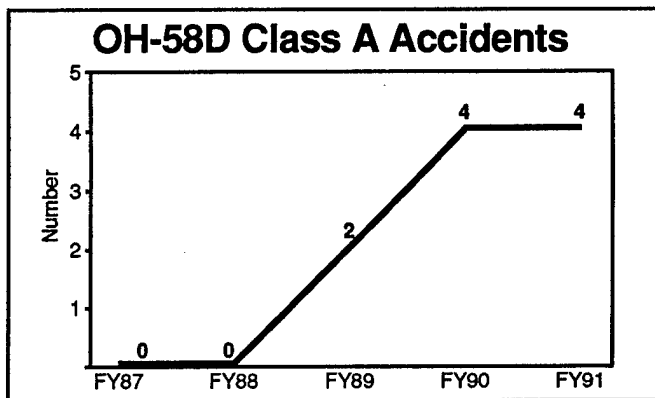
Figure 3-2 shows OH-58D Class A accidents.

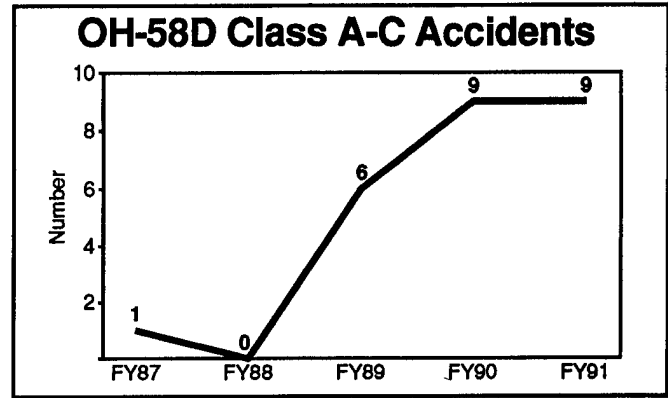
Figure 3-3 shows the OH-58D Class A-C accident trend. FYs 88 through 90 show a significant increase, with FYs 90 and 91 high due to DS/S.

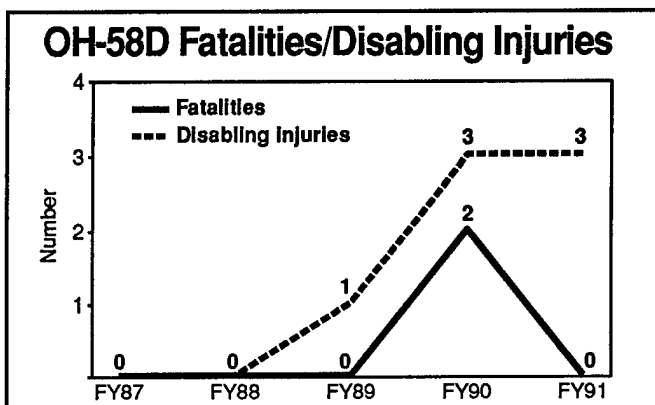
Figure 3-4 shows fatalities and disabling injuries resulting from OH-58D accidents.

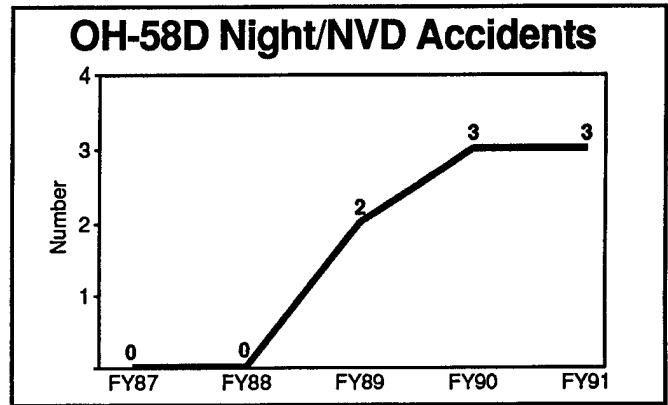
Figure 3-5 shows OH-58D Class A accidents that occurred at night. In all cases, crews were using NVDs.

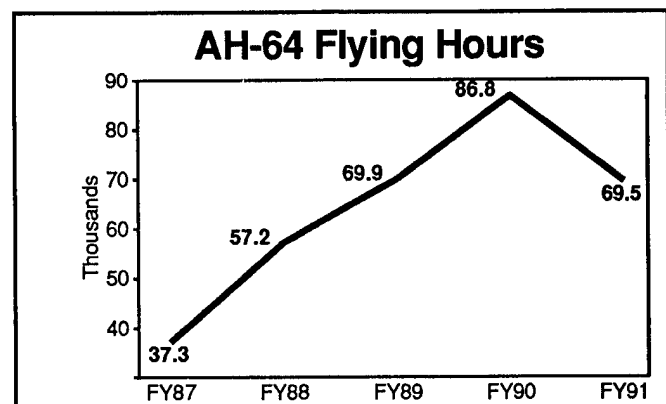
Figure 4-1 shows a significant increase in AH-64 flying hours through FY 90. The reduction in FY 91 resulted from flying hours being pulled from units and given to DS/S deployed units.

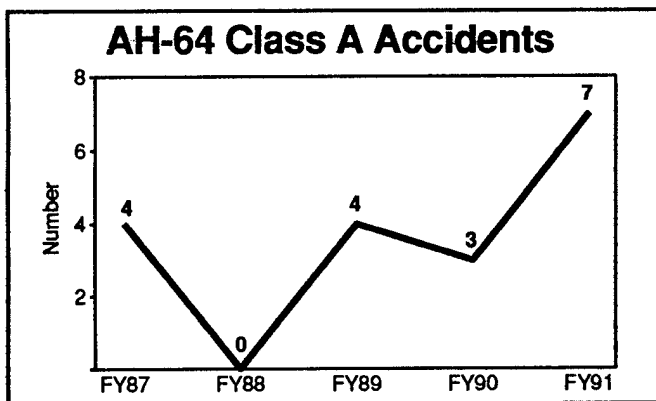
Figure 4-2 shows AH-64 Class A accidents. Particularly noteworthy is the fact that, until DS/S,

flying hours steadily increased, but Class A accidents did not.

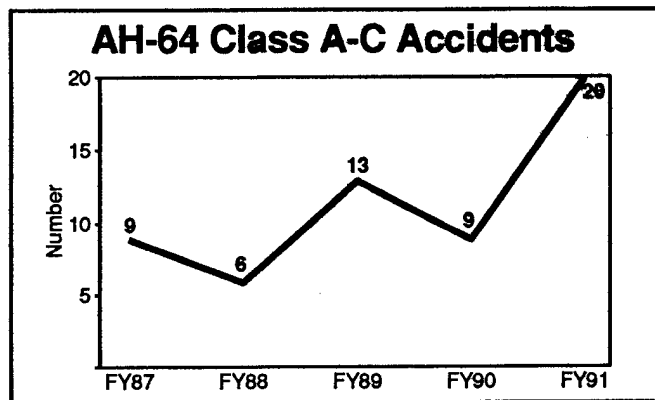
Figure 4-3 shows the AH-64 Class A-C accident trend.

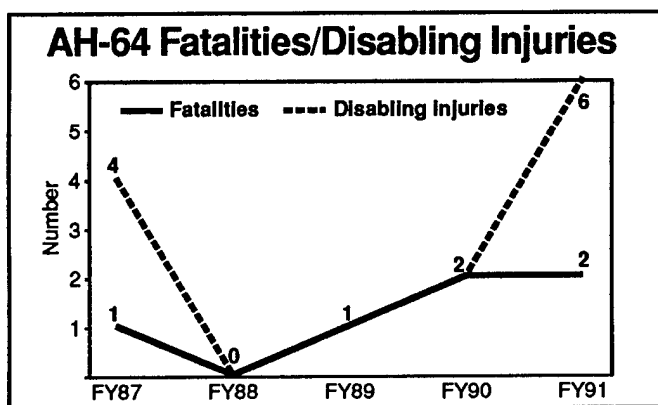
Figure 4-4 shows the fatalities and disabling injuries resulting from AH-64 accidents.

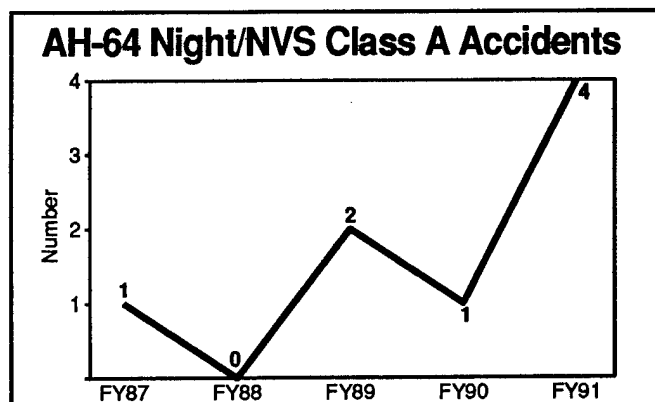
Figure 4-5 shows AH-64 Class A accidents that occurred at night. Note that in all 8 cases, crews were using NVSs.

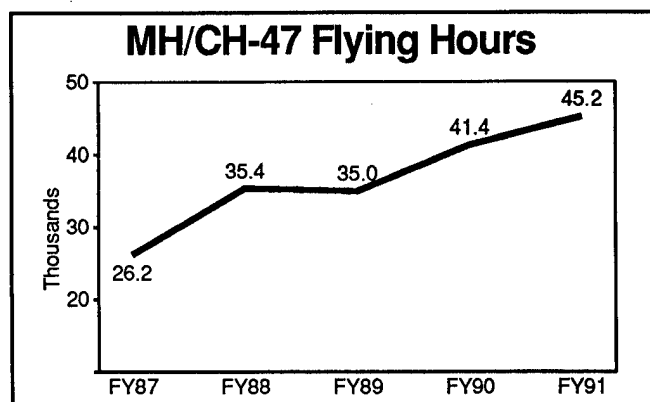
Figure 5-1 shows a significant increase in MH/CH-47D flying hours through FY 91.

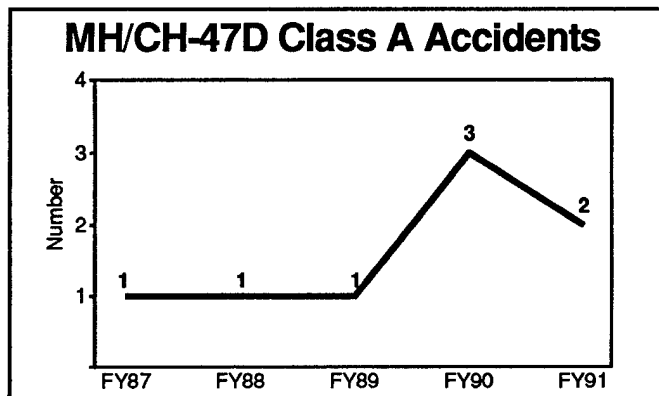
Figure 5-2 shows MH/CH-47D Class A accidents during the 5-year period.

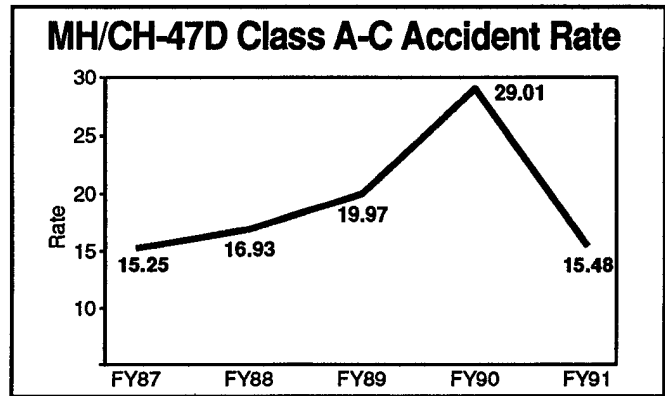
Figure 5-3 shows MH/CH-47D Class A-C accident rates per 100,000 flying hours.

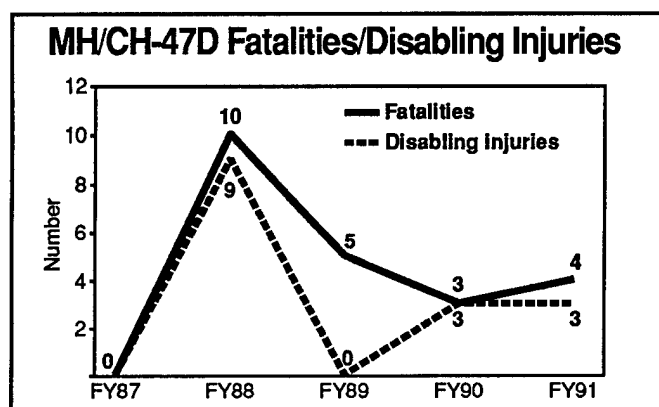
Figure 5-4 shows the fatalities and disabling injuries resulting from MH/CH-47D accidents.

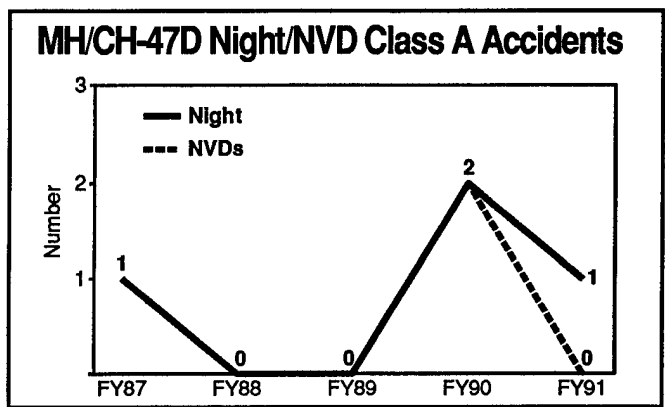
Figure 5-5 shows MH/CH-47D Class A accidents that occurred at night. Note that in 3 of the 4 cases, NVDs were in use.
